DEPARTMENT OF TRANSPORTATION

Contract #: 04-0120F4Cty: SF/ALA Rte: 80 PM: 13.2/13.9File #: 1.28**WELDING INSPECTION REPORT****Resident Engineer:** Casey, William**Address:** 333 Burma Road**City:** Oakland, CA 94607**Report No:** WIR-029881**Date Inspected:** 25-Jul-2013**Project Name:** SAS Superstructure**OSM Arrival Time:** 700**Prime Contractor:** American Bridge/Fluor Enterprises, a JV**OSM Departure Time:** 1530**Contractor:** American Bridge/Fluor Enterprises, a JV**Location:** Job Site**CWI Name:** As noted below**CWI Present:** Yes No**Inspected CWI report:** Yes No N/A**Rod Oven in Use:** Yes No N/A**Electrode to specification:** Yes No N/A**Weld Procedures Followed:** Yes No N/A**Qualified Welders:** Yes No N/A**Verified Joint Fit-up:** Yes No N/A**Approved Drawings:** Yes No N/A**Approved WPS:** Yes No N/A**Delayed / Cancelled:** Yes No N/A**Bridge No:** 34-0006**Component:** Tower**Summary of Items Observed:**

WELDING INSPECTION REPORT

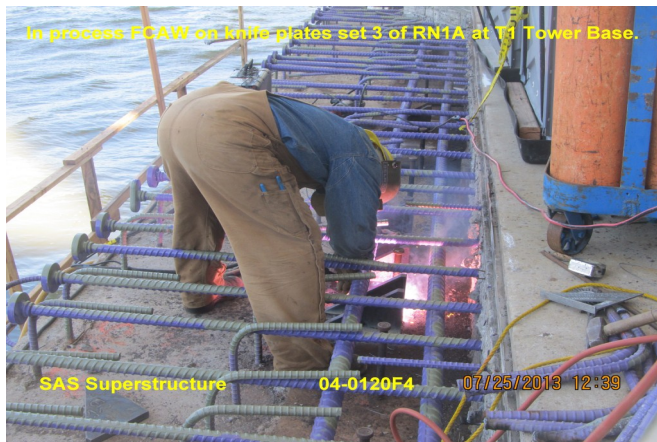
This QA observed, at random intervals, Dutra welder Dave Selba #29470565 performing Flux Core Arc Welding (FCAW) with .072 diameter E71T-8 electrode and implementing Welding Procedure Specification (WPS) Dutra Knife Plate Revision 0. Welding was performed on Knife Plates to Top Plate.

RN1A Set 1-5 was completed on this date. (A set consists of two Knife Plates.)

This QA Inspector performed 10% Magnetic Particle (MT) testing along the length of, and the edges of the knife plate on the Top Plate at RN1A 1-5. This QA Inspector performed MT testing utilizing the yoke method in conformance with ASTM E 709 and the standard of acceptance with D1.5 section 6.26.2.1. This QA Inspector noted that no rejectable indications were found at the time of testing. This QA Inspector generated a TL-6028 MT report on this date. The completed work at this location appeared to be in general conformance with the contract
